FLIGHT TESTS OF VARIOUS TAIL MODIFICATIONS

ON THE BREWSTER XSBA-1 AIRPLANE

I - MEASUREMENTS OF FLYING QUALITIES

WITH ORIGINAL TAIL SURFACES

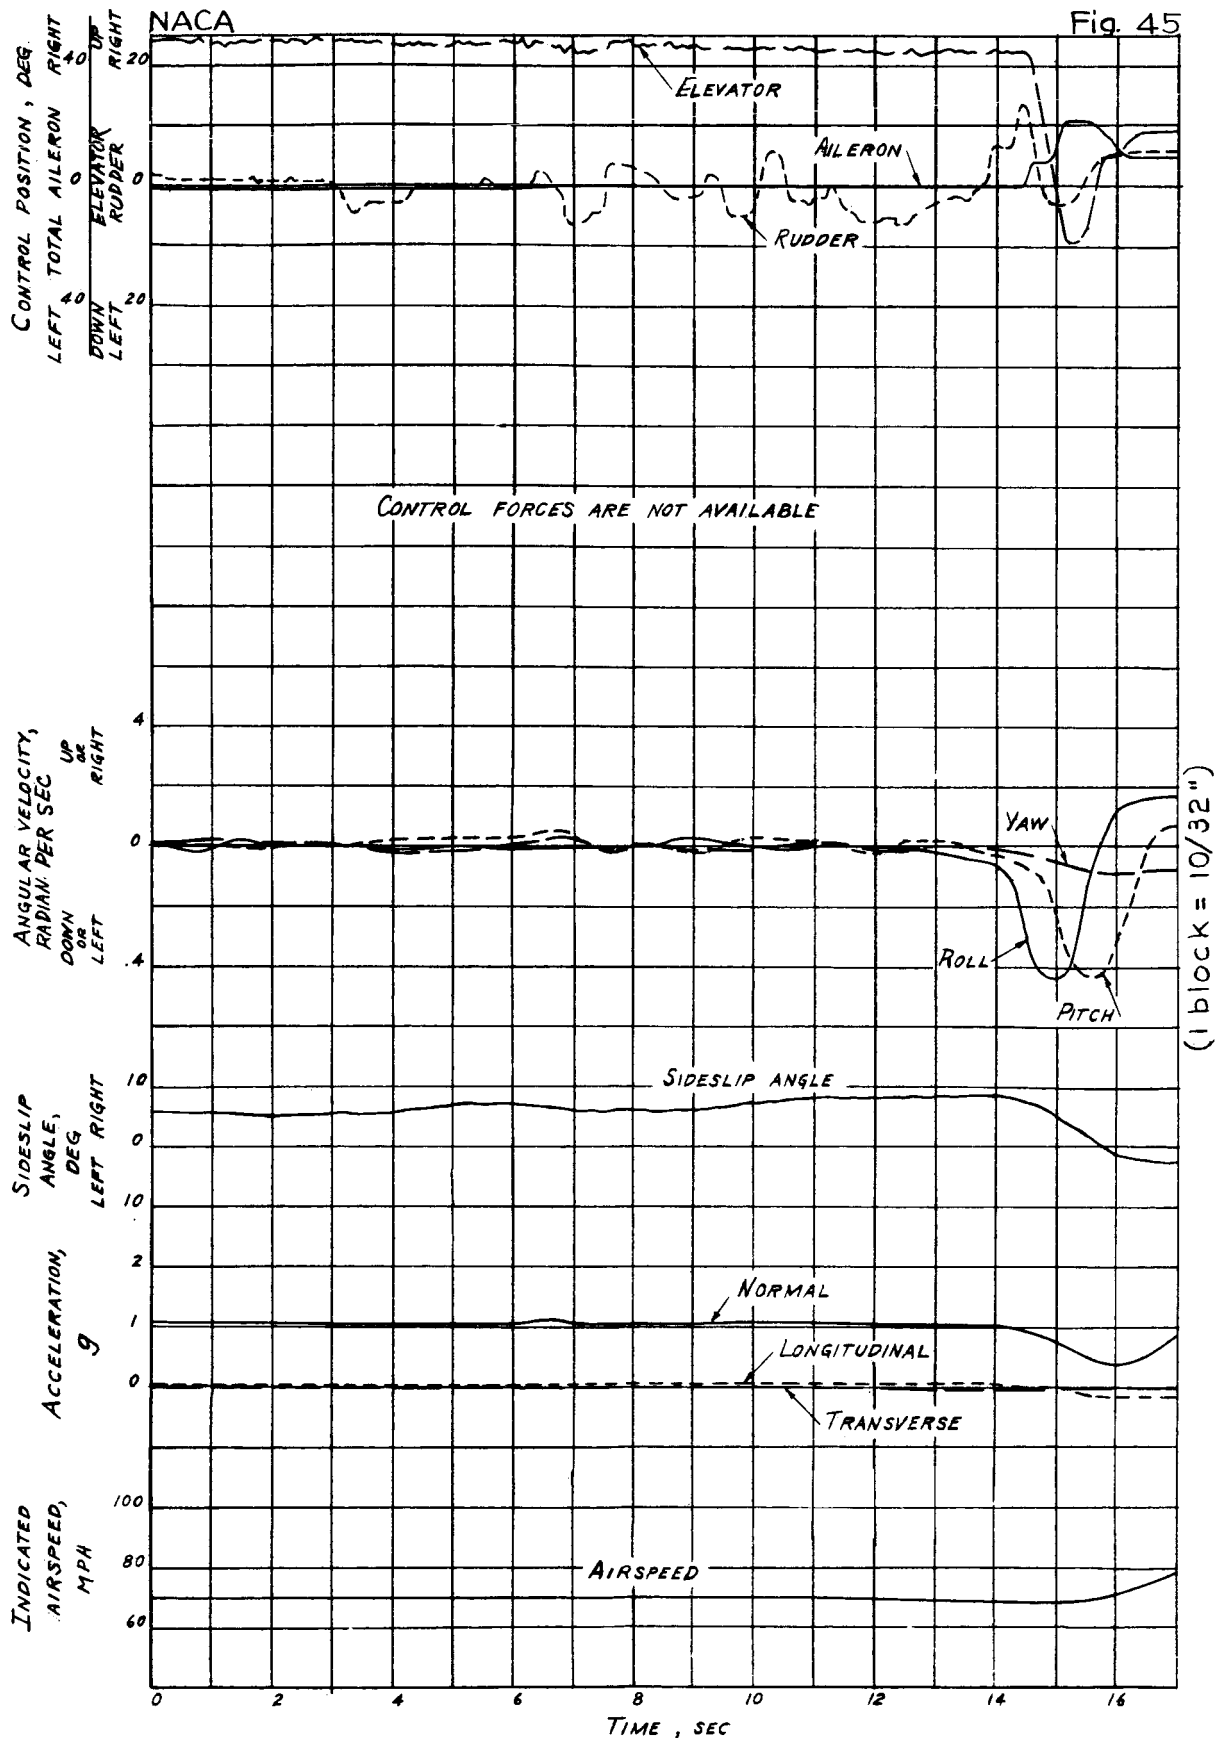
Figure 45. - Time history of a stall in the landing condition (flaps down, gear down, power off). Control maintained by use of rudder until roll-off to the left occurred. Brewster XSEA-1 airplane.

The results of these tests are presented in the form of time histories (figs. 37 to 48). The conclusions reached are as follows:

11. The stalling characteristics were good. Adequate stall warning existed in all conditions of flight in the form of pitching and rolling motions of the airplane. Control of the airplane in a partly stalled condition could be

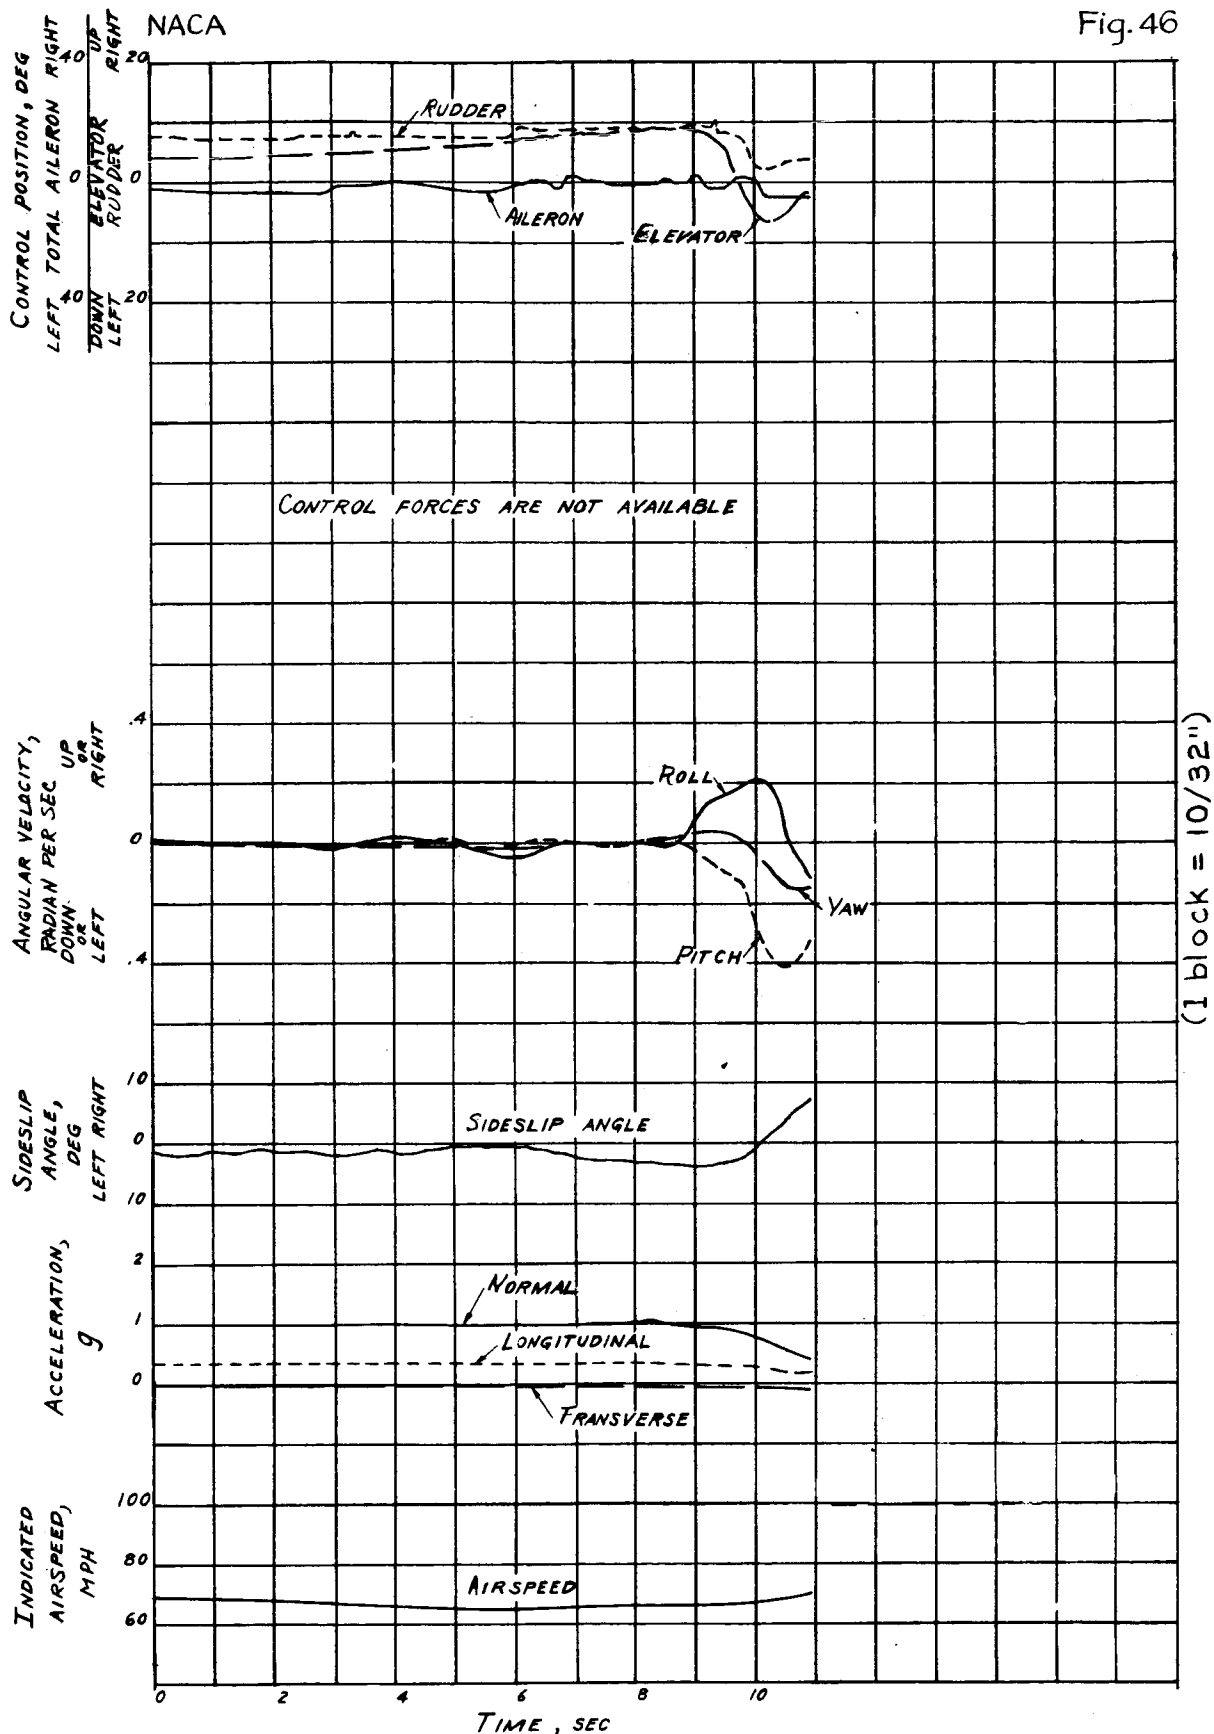
Figure 46. - Time history of a stall in the take-off condition (flaps up, gear down, 35 inches Hg manifold pressure, 2050 rpm). Controls held fixed until mild roll-off to right occurred. Note stall warning in form of rolling and pitching oscillation. Brewster XSBA-1 airplane.

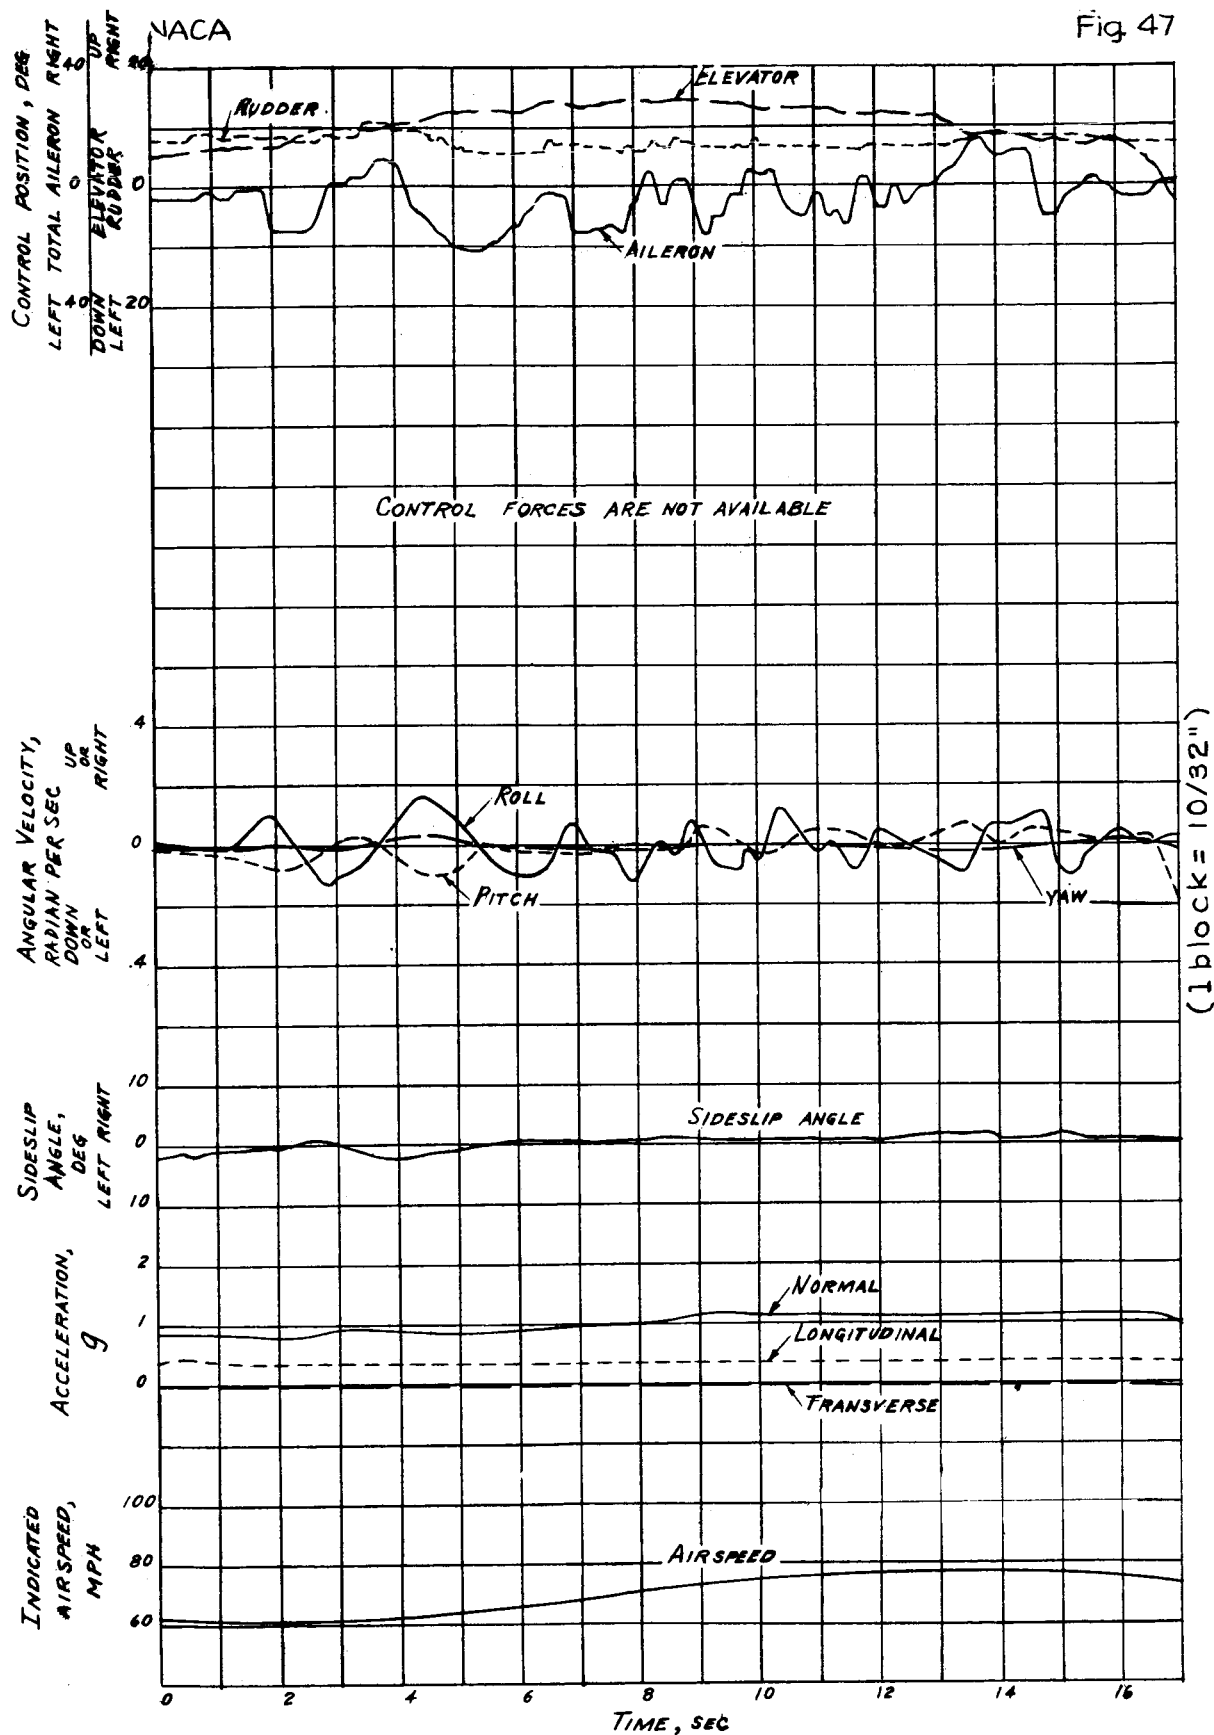
Figure 47. - Time history of a stall in the take-off condition (flaps up, gear down, 35 inches Hg manifold pressure, 2050 rpm). Control maintained by use of the ailerons. Brewster XSEA-1 airplane.

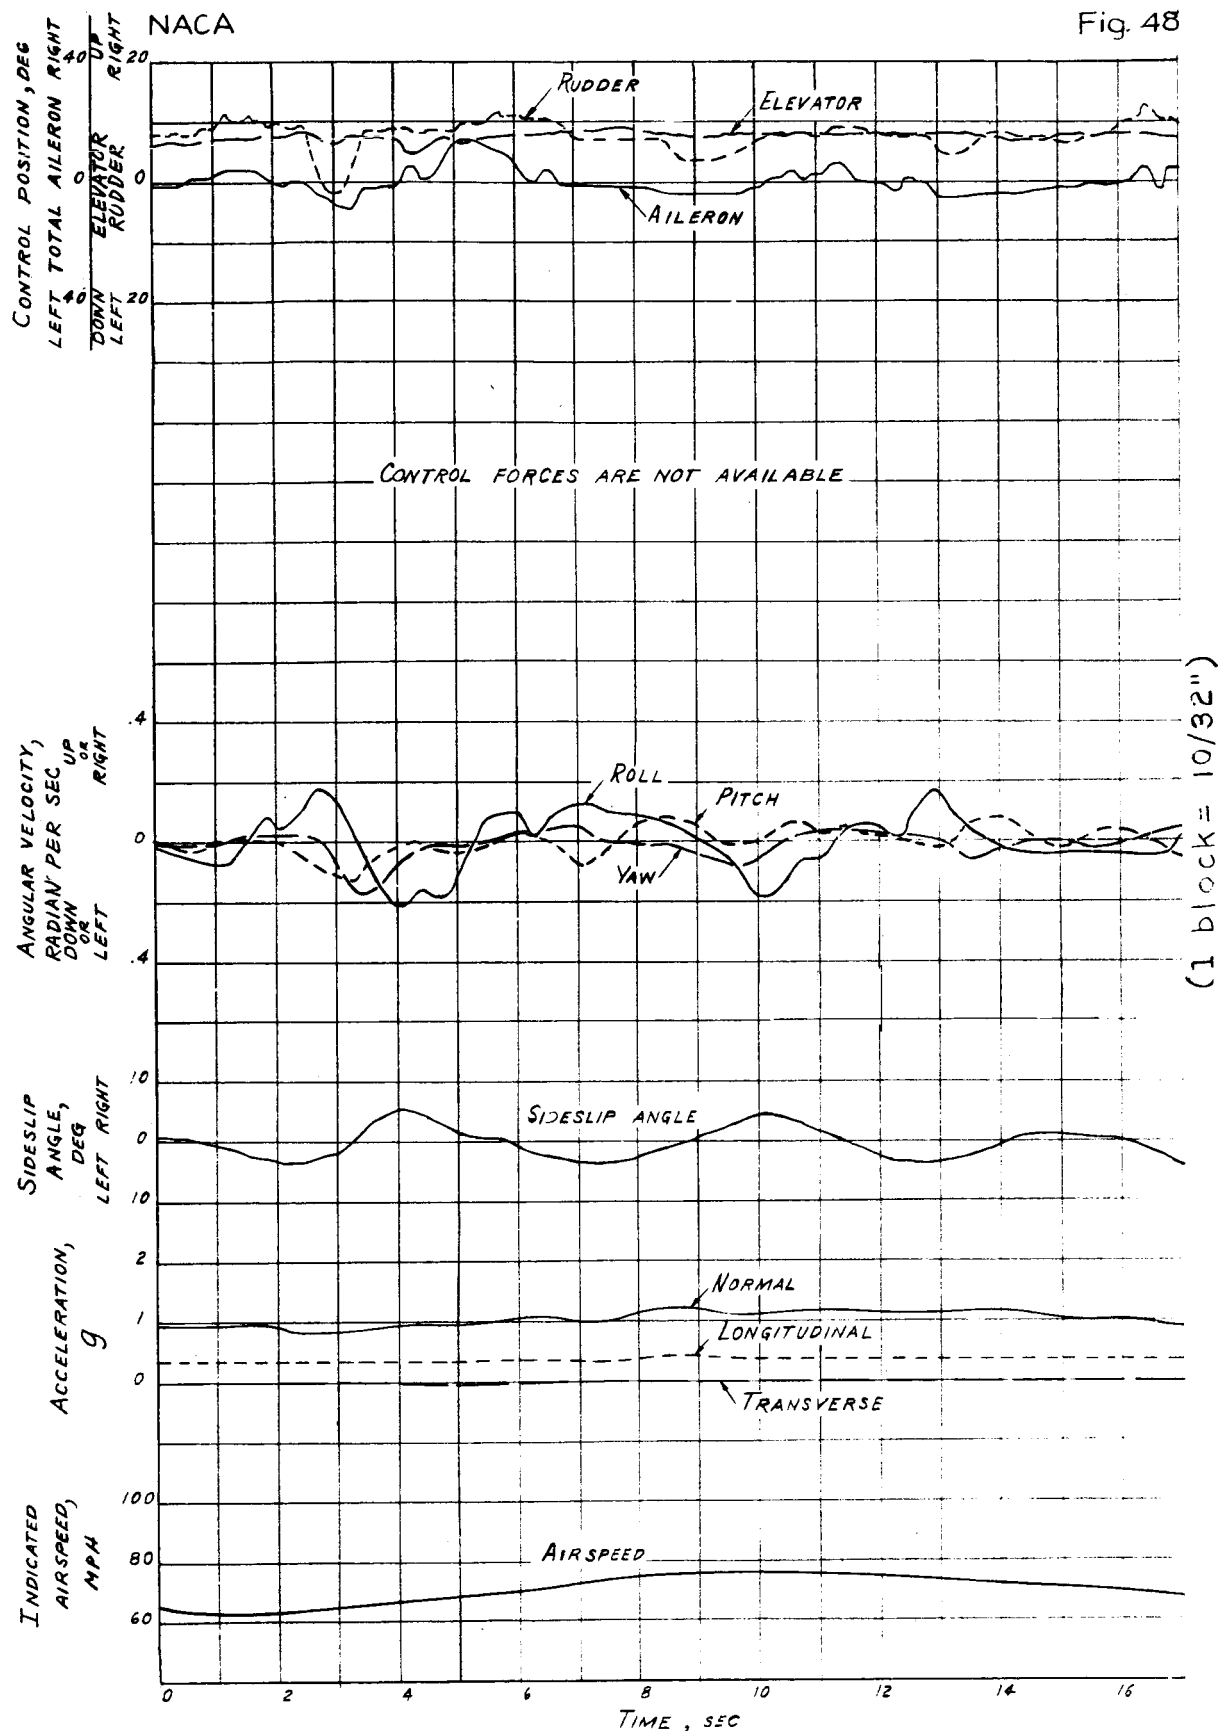
Figure 48. - Time history of a stall in the take-off condition (flaps up, gear down, 35 inches Hg manifold pressure, 2050 rpm). Control is maintained by use of the rudder, though rolling oscillation is rather violent. Brewster XSBA-1 airplane.
